# Manhole Inspection Summary

Manhole # S29Q\_\_037MH

Insp Date: **11/4/08 10:26 AM**

**Location** Address: **710 W. Ostend**

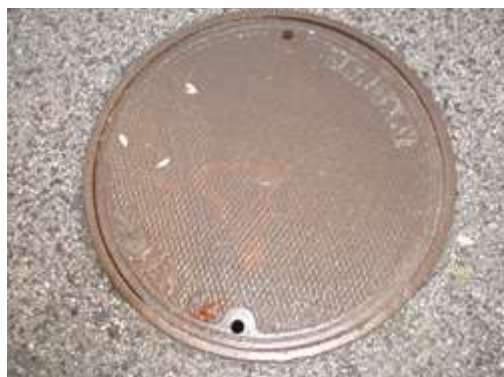
misc-1

MH Cover pic

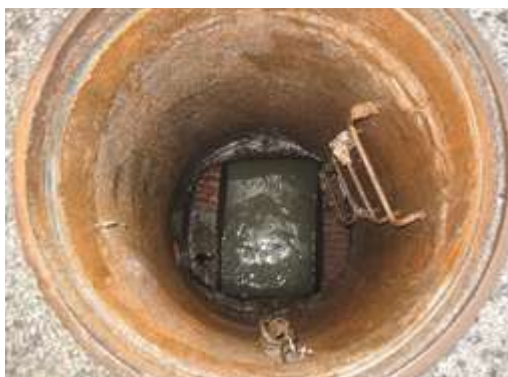
Defect 4

☒ **Leaks**

frame/lid infiltration

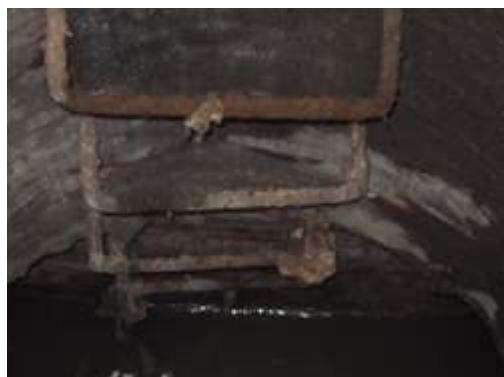
Defect 3

☒ **Evidence Of Surcharge** Depth: **8** (ft.) ☐ Active Surcharge Present

Surcharge Evidence

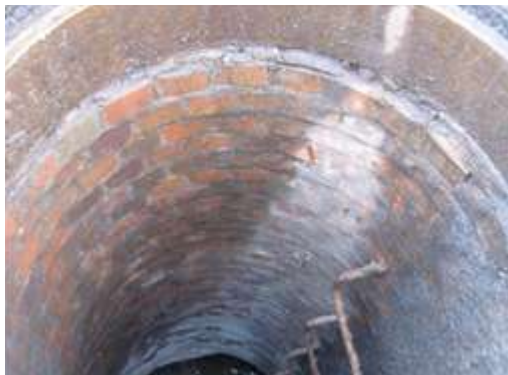
Defect 2

Infiltration: ☐ None ☐ Joint ☐ Cracks ☐ Mortar ☐ Roots ☒ **Wall**

infiltration at chimney & corbel walls

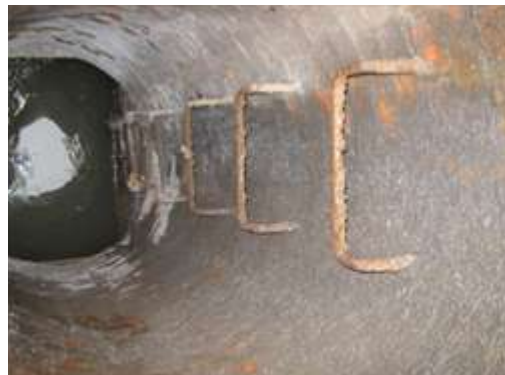
Defect 1

Count: **7** Missing: **1** ☒ **Corroded**

corroded rungs; 1 missing

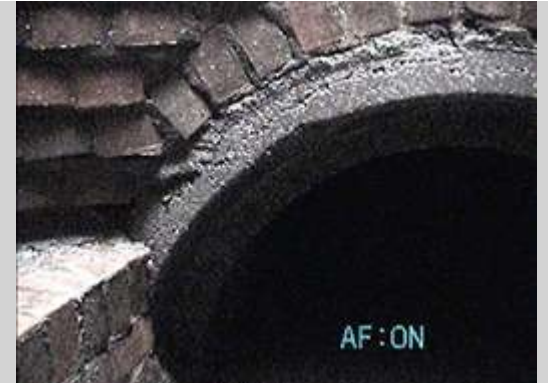
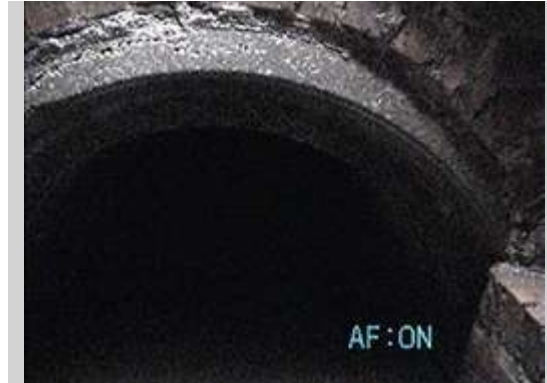
12 O'Clock Outflow

Pipe Height: **30** (in.) Rod and Bar (Angled)  
Pipe Material: **Clay** ☐ Pipe Lined  
Invert Depth: **13.80** (ft.) Flow Characteristics: **Fast**  
Deposits: ☐ None ☒ **Mud** ☒ **Sludge** ☐ Debris ☐ Grease  
Silt Depth: **4** (in.) Deposits Extent: **Medium**  
Infiltration: **None** Pipe Seal Cond: **Sound**

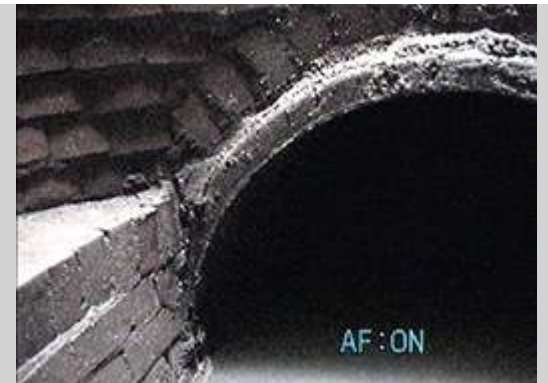
6 O'Clock Inflow

Pipe Height: **30** (in.) Rod and Bar (Angled)  
Pipe Material: **Clay** ☐ Pipe Lined  
Invert Depth: **13.69** (ft.) Flow Characteristics: **Fast**  
Deposits: ☐ None ☒ **Mud** ☐ Sludge ☐ Debris ☐ Grease  
Silt Depth: **4** (in.) Deposits Extent: **Medium**  
Infiltration: **None** Pipe Seal Cond: **Sound**
